WT-1631

(6) DAMAGE *to* EXISTING EPG STRUCTURES (U) *(U)*

This report presents the final results of one of the projects participating in the military-effects programs of Operation Hardtack. Overall information about this and the other military-effects projects can be obtained from ITR-1660, the "Summary Report of the Commander, Task Unit 3." This technical summary includes: (1) tables listing each detonation with its yield, type, environment, meteorological conditions, etc.; (2) maps showing shot locations; (3) discussion of results by programs; (4) summaries of objectives, procedures, results, etc., for all projects; and (5) a listing of project reports for the military-effects programs.

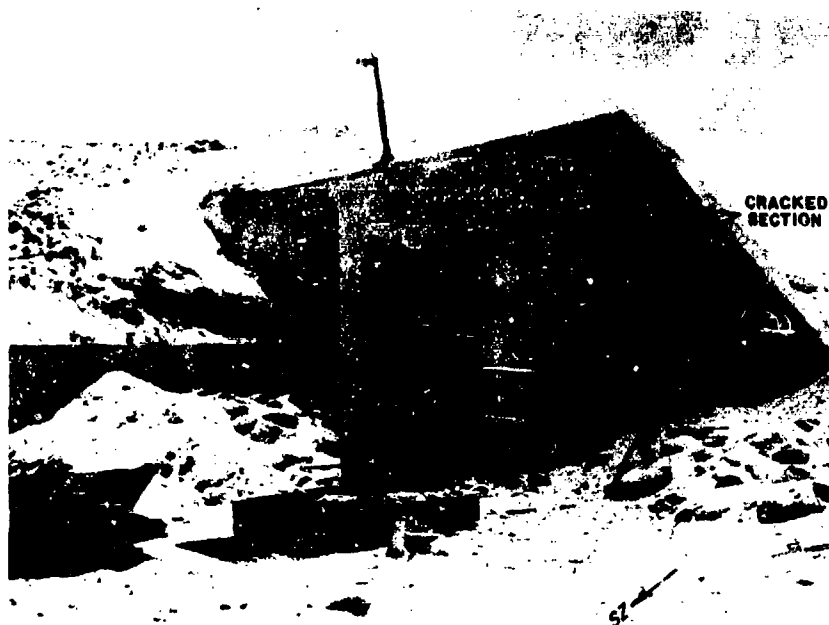
Figure 4.5 Post-Yellowwood, (Item 18) station complex, close-up of entrance and cracked wing wall. Pressure levels: Koa, 42 psi; Yellowwood, 11.5 psi; and Tobacco, 1.9 psi.

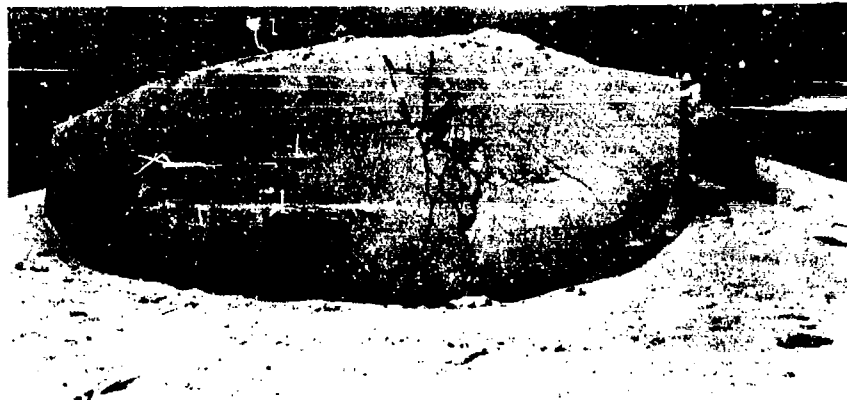
Figure 4.9 Post-Koa, (Item 19) Station 1525, face-on view.
Pressure level: Koa, 42 psi; 350 cal/cm^2 .

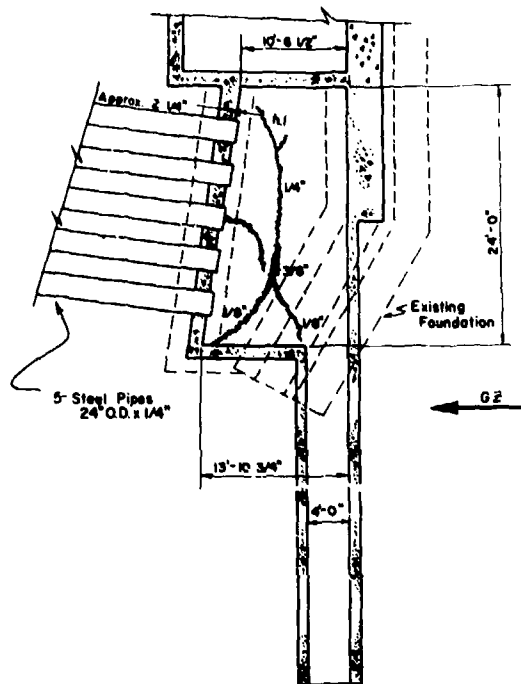
The plain-concrete floor of this station was badly cracked and the five 24-inch pipes entering this station were forced inward about $2\frac{1}{4}$ inches (Figure 4.18). The crack pattern (shown in Figure 4.19) indicates that the existing foundation underneath part of the floor gave additional support to that portion.

Figure 4.19 Post-Koa, (Item 20) Station 1311, crack pattern in floor. Pressure level: Koa, 42 psi.

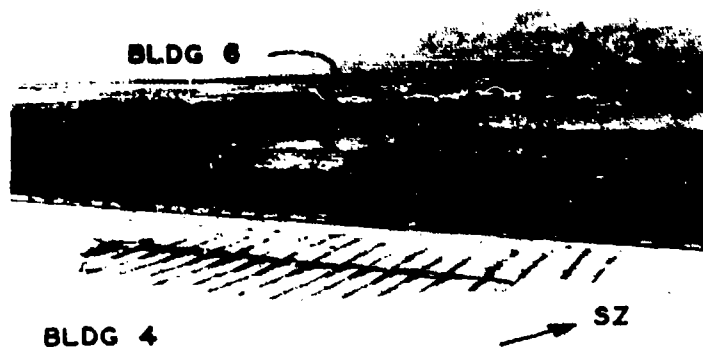
Figure 4.61 Post-Elder, (Item 26) Station 3.1.1, destroyed roof section of Building 6 and damaged area to roof at south end of Building 4. Pressure level: Elder, 20 psi.

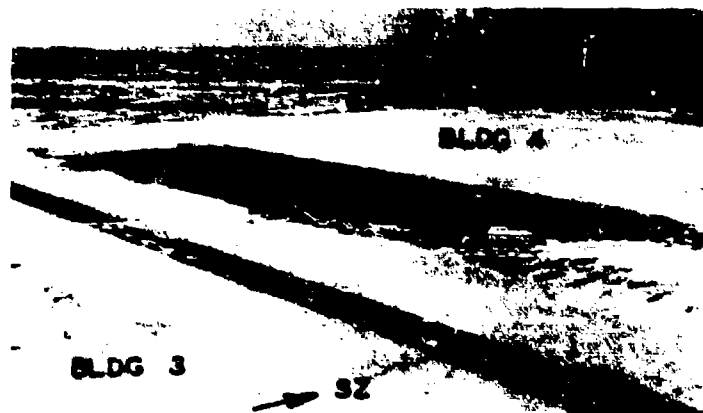
Figure 4.62 Post-Elder, (Item 26) Station 3.1.1, outside view of punched-in roof section at north end of Building 4. Pressure level: Elder, 20 psi.

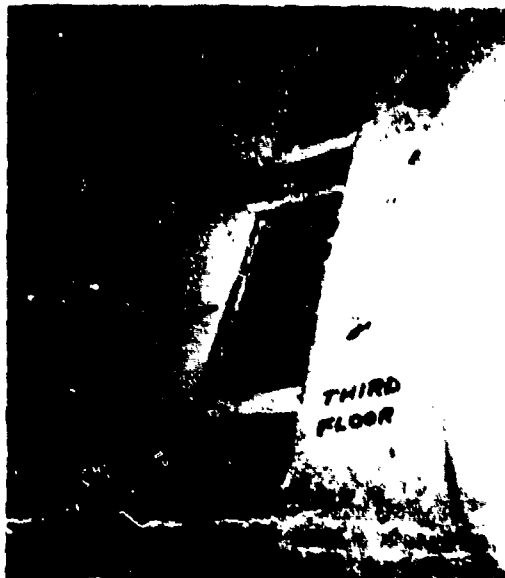
Figure 4.67 Post-Dogwood, -Olive, and -Pine, (Item 26)
Station 3.1.1, crack in third floor at intersection of front
wall between Column Line 11 and south shear wall. Pres-
sure levels: Dogwood, 12 psi; Olive, 8.4 psi; and Pine,
13 psi.

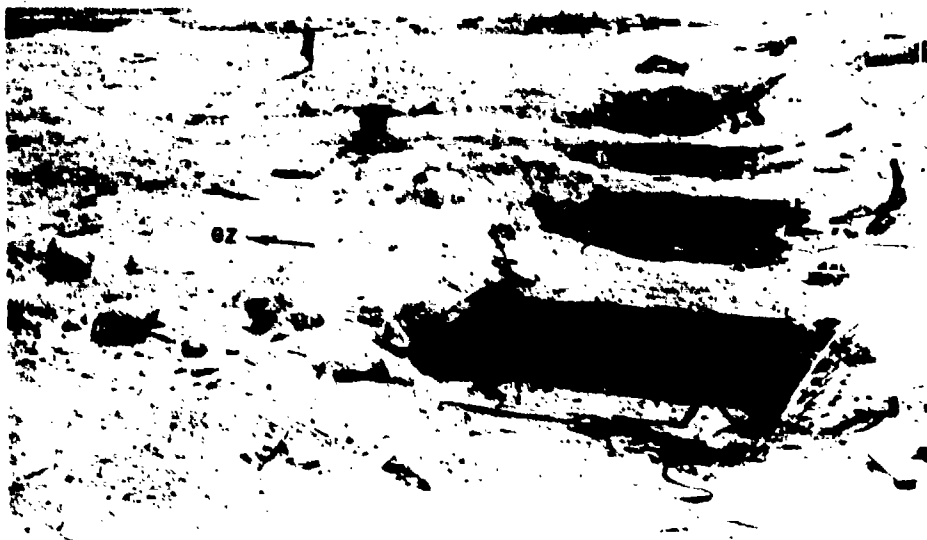
Figure 4.92 Post-Cactus, (Item 35) Stations 1523.01 to 1523.04, foundation pit for towers. Pressure level: Cactus, 450 psi.

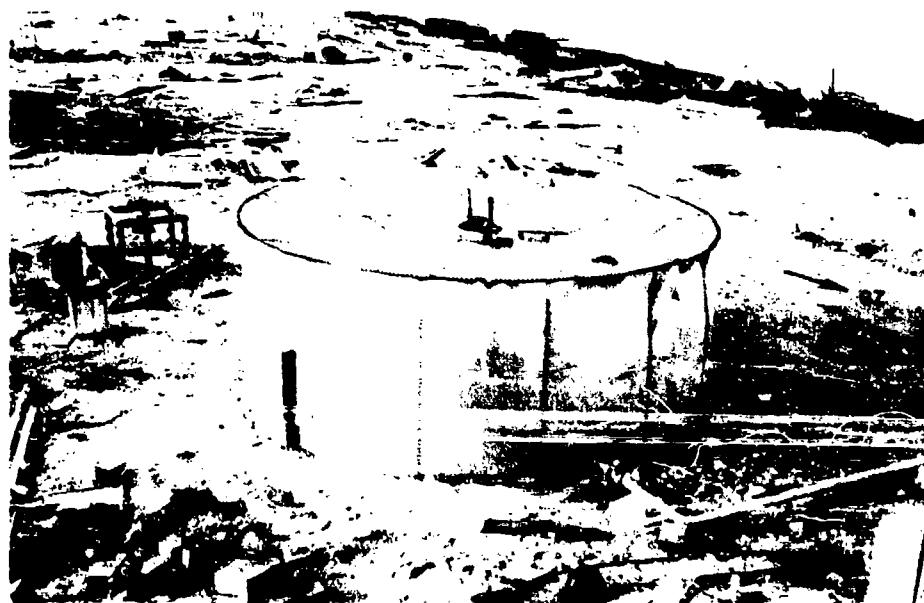
A ground-surface 21,000-gallon water tank of $\frac{1}{8}$ -inch bolted steel plate, 8 feet high and 22 feet in diameter, suffered only light damage when exposed to pressures of 6.5 and 7.0 psi.

Figure 4.97 Post-Magnolia, (Item 37) 21,000-gallon water tank and
Yvonne Camp area. Pressure level: Magnolia, 7.0 psi.

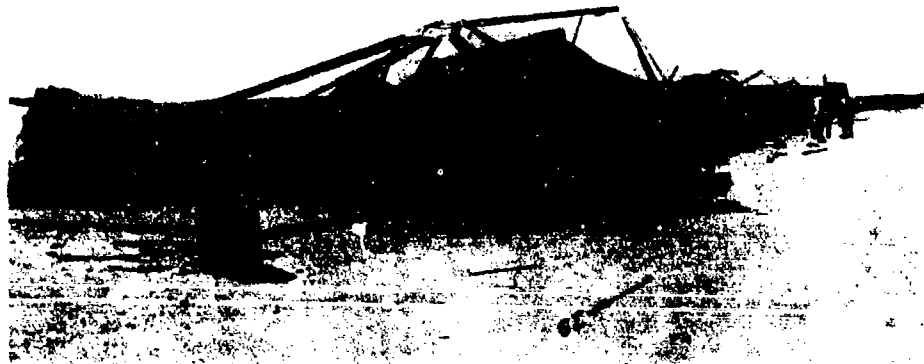
Figure 4.98 Post-Cactus, camp damage, tents. Pressure level: Cactus, 2.0 psi.

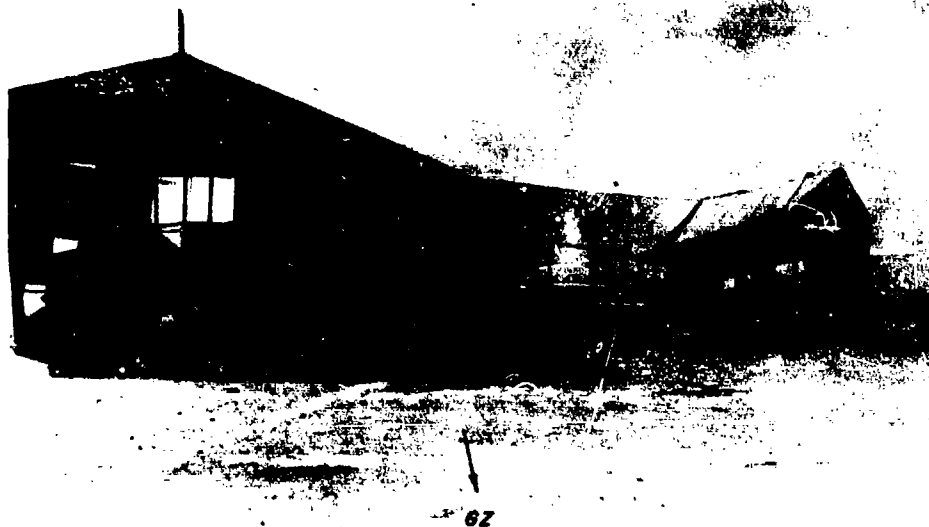
Figure 4.99 Post-Cactus, camp damage, light timber construction.
Pressure level: Cactus, 1.5 psi.

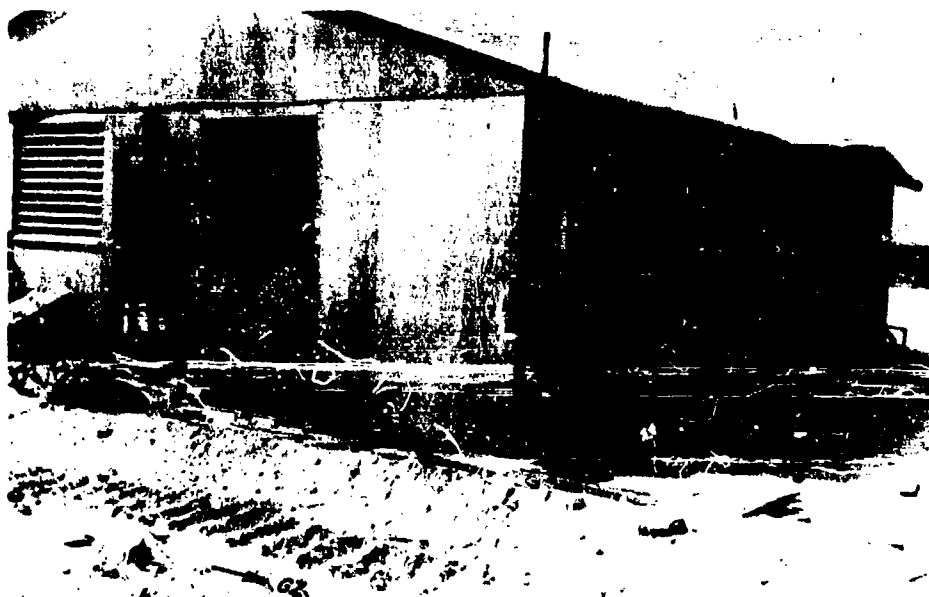
Figure 4.100 Post-Cactus, camp damage, latrine. Pressure
level: Cactus, 2.0 psi.

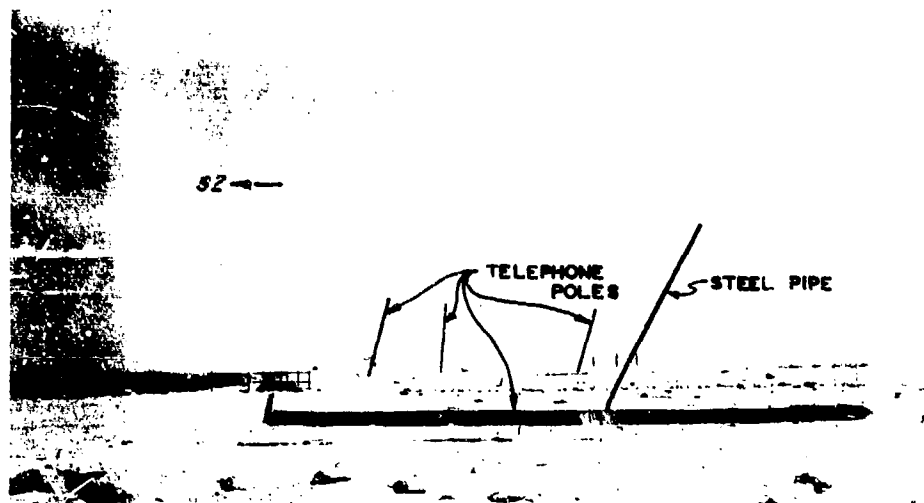
Figure 4.101 Post-Butternut, telephone poles. Pressure level: Butternut, 12 psi.
